Queensland BHP Steel: diagnosis of a fan bearing problem

by **Peter Cleary**
*Process Efficiency Engineer,
Queensland BHP Steel
Acacia Ridge, Queensland, Australia*
and **David Eden**
*Managing Director,
Rotor Dynamics Pty. Ltd.
Oatley, New South Wales, Australia*

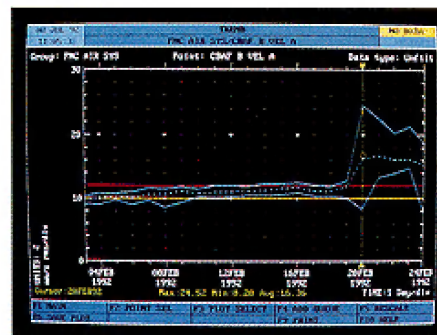
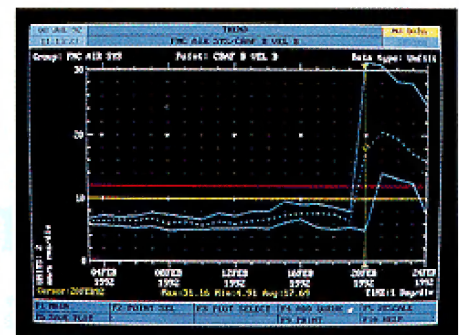
Figure 2
Trend plots made by the velocity transducers (left, A;
right, B) showing a sudden increase in amplitude.

A velocity transducer was installed on each plummer block and connected to the Trendmaster® 2000 System. The next temperature excursion was reported on 20 February 1992, the same day that both Trends made by the velocity transducers underwent a sudden increase in amplitude (Figure 2). In addition, the Spectra of the velocity transducer signals showed a sizeable increase in energy at 2X shaft speed (Figures 3-4). The maximum amplitudes of the velocity probe signals had been increasing slowly, but steadily, before the sudden increase in amplitude. The minimum amplitudes also changed but not as consistently as the maximum amplitudes.

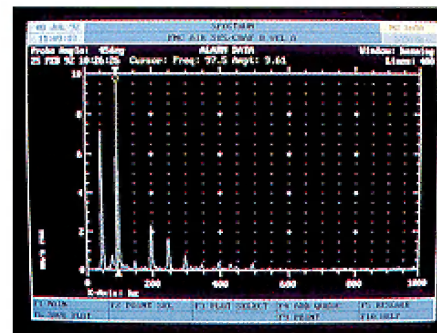
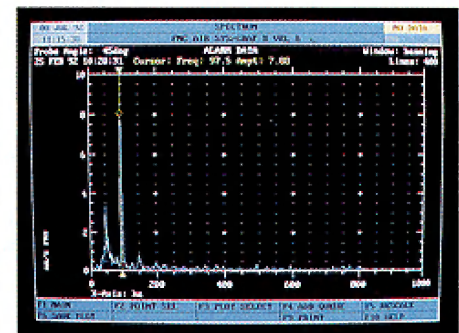
Figure 3
Spectrum plots made by the velocity transducers (left, A;
right, B) showing a sizeable increase in energy at 2X shaft speed.

Close inspection of the Spectrum of the pulley end velocity probe signal (Figure 3) showed that the broad band of frequencies above and below shaft speed contained small peaks. When they were first noticed, it was apparent that they were mostly multiples of approximately 10 Hz. The length of the vee-belts was approximately five times the pitch circumference of the fan pulley, implying that the fundamental frequency of the belts was about 10 Hz. Thus, the broad band of frequencies around shaft speed could be confidently associated with a deterioration in vee-belt condition. The spacing between the small peaks later

became somewhat less regular, and peaks appeared at other frequencies.

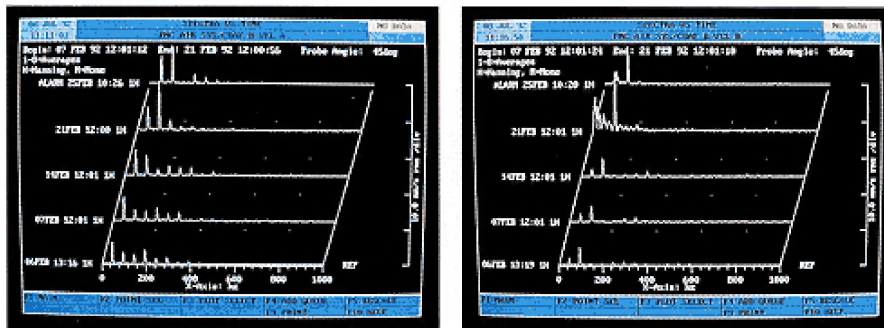
Figure 4
Spectra versus Time plots made by the velocity transducers (left, A;
right, B) showing increasing energy at 2X shaft speed.
